CASE STUDY

## Factory production continues while floor stabilisation takes place

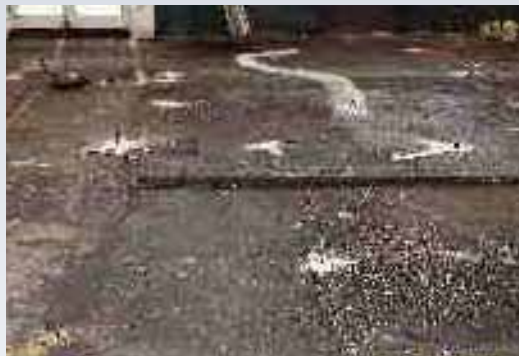
Before

Supplying a major order on a short deadline, premier UK air conditioning ductwork manufacturer Hotchkiss Ductwork could not afford to slow down production to repair settlement of 1,000m<sup>2</sup> of manufacturing space at their factory in Eastbourne, Sussex. Built on an originally marshy mix of peat and clay, the main production unit floor had settled up to 200mm across its length and breadth in a saucer-like subsidence.

Uretek's resin injection process was chosen for the repair because it can be applied without the need for factory closure. According to Rodney Fox, Operations Director for Hotchkiss: "Following Uretek's inspection, two teams came into the factory for a two-week period. Uretek's technicians worked on the factory floor with production going on all around them. They were highly flexible and co-operated well with our workforce. "The job is very impressive. In fact, it's hard to see what they have done! The whole floor slab is now significantly level and we believe it will give us many more years of profitable service."
